Inspection Report

Mine Name: Alta Helena

Permit number: Assigned
S0350034 (Unpermitted)

Inspection Date: June 29, 2007
Time: about 9:45 to 10:30 AM

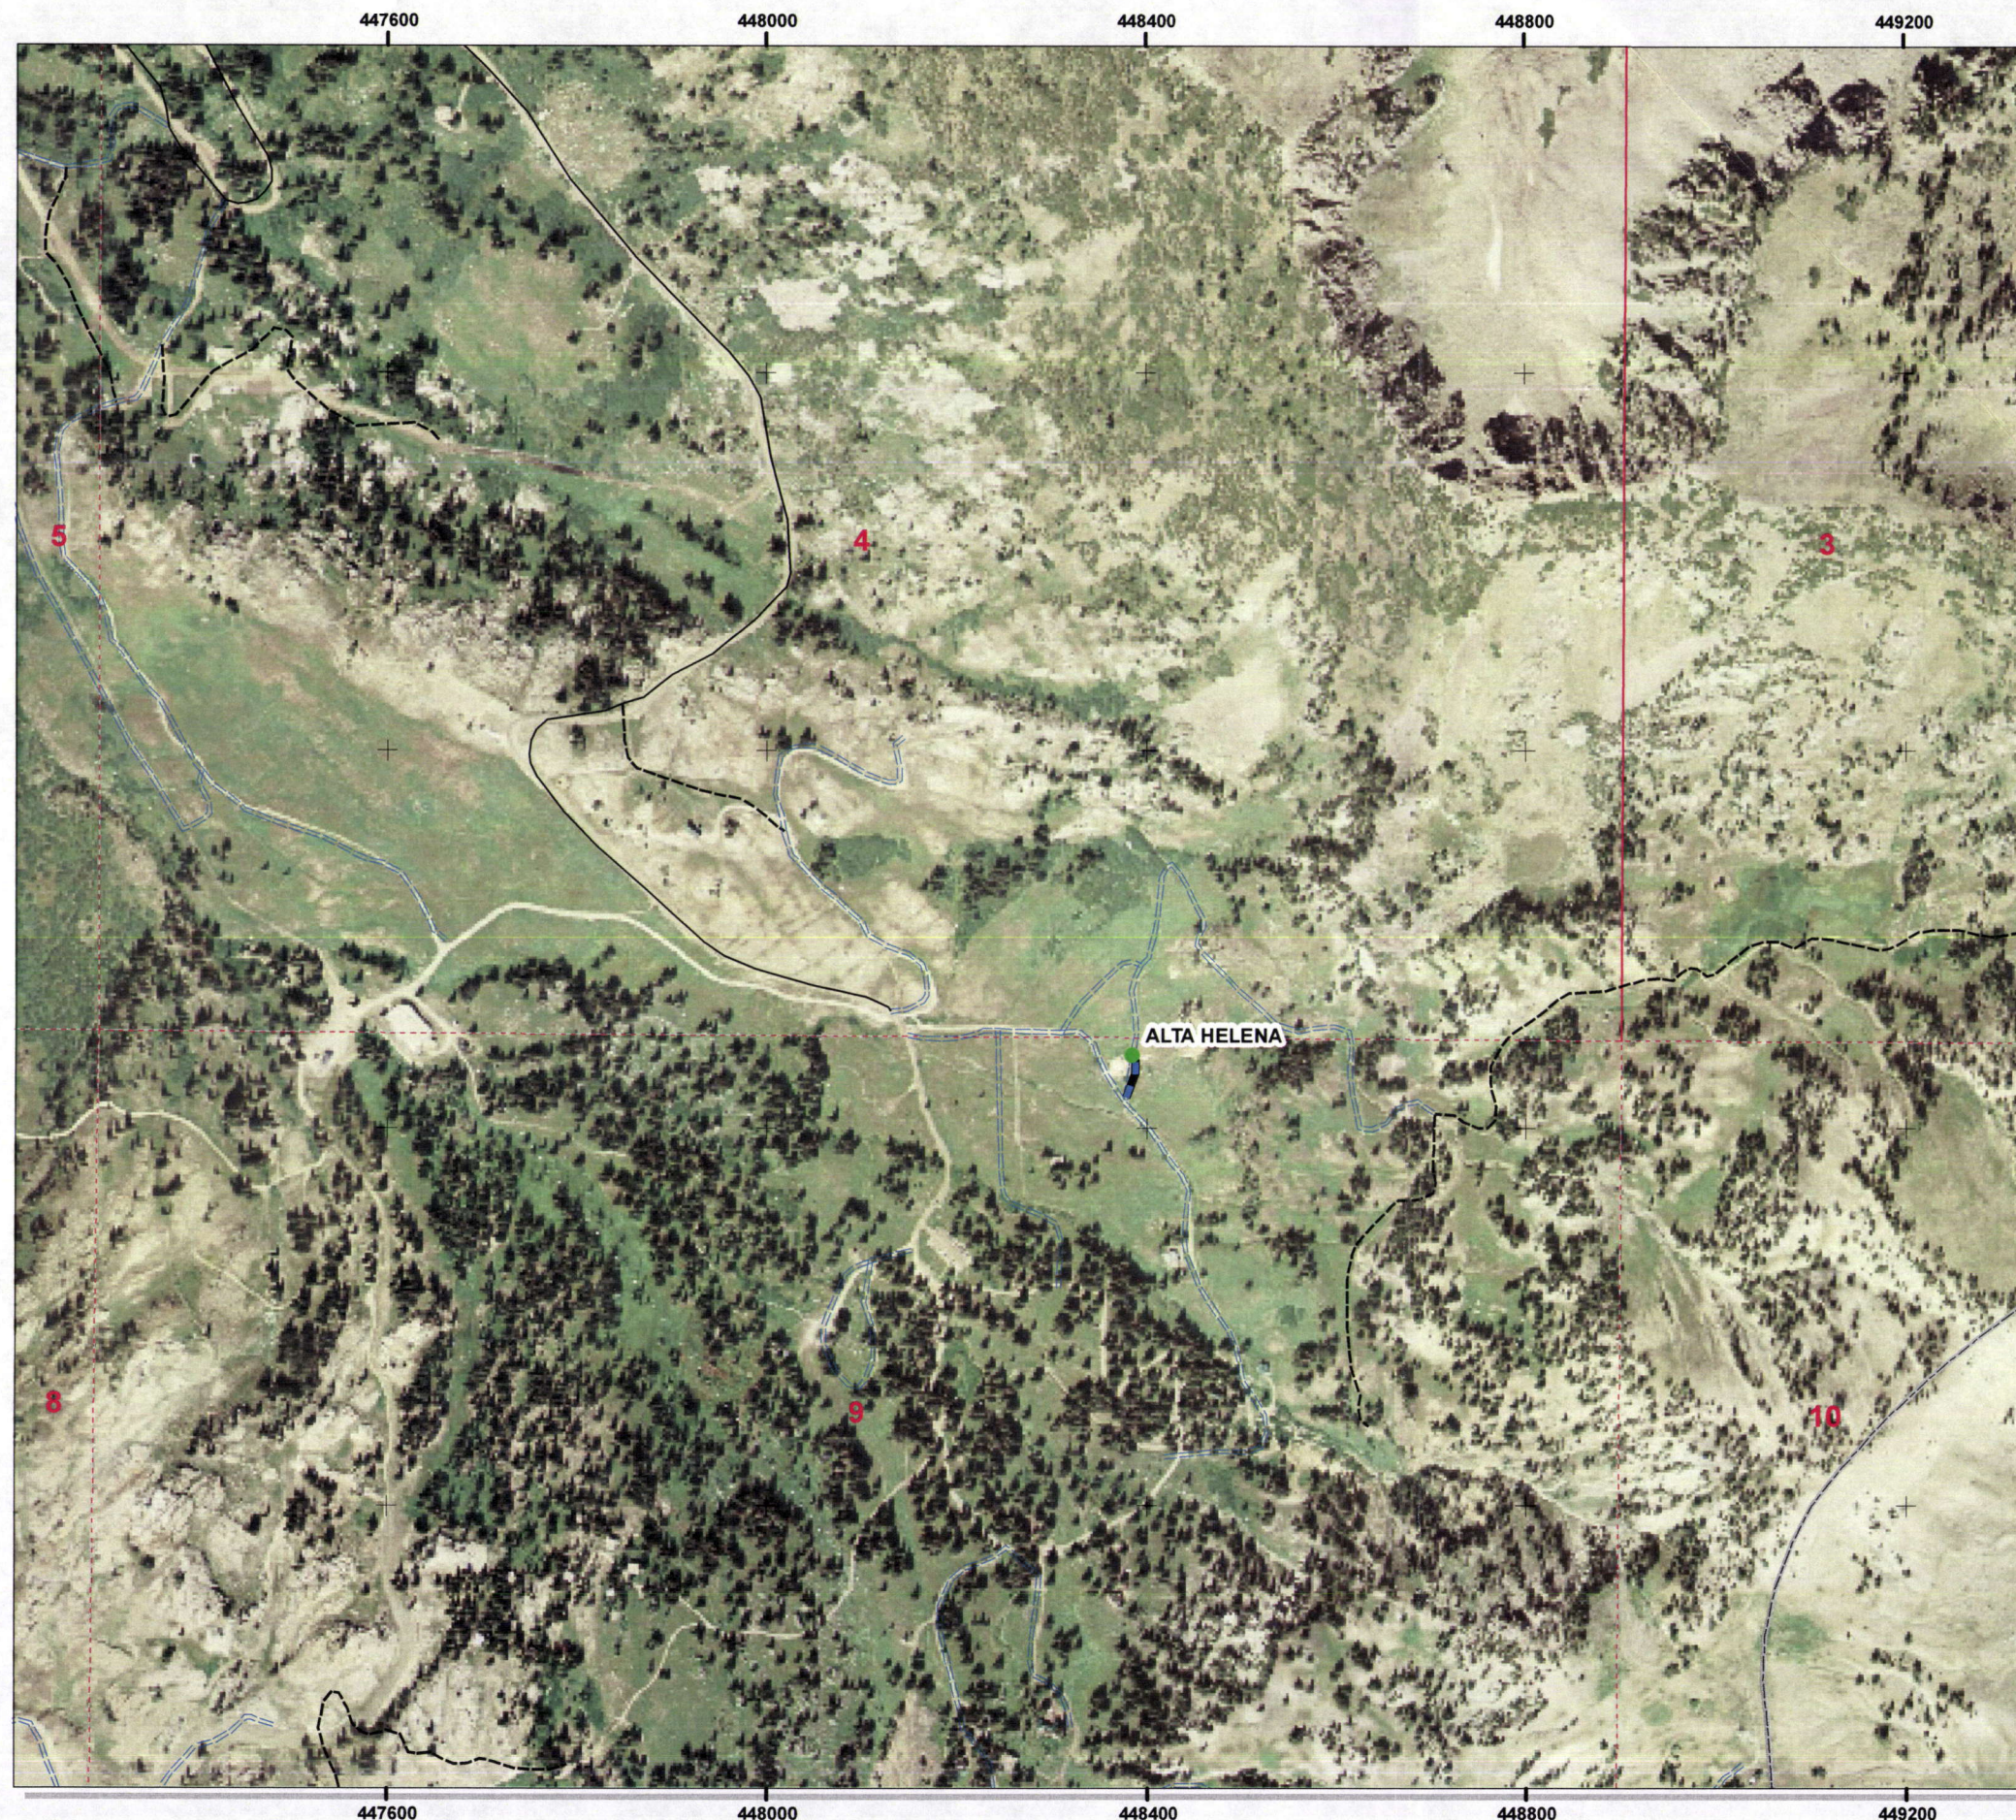
We found numerous grass seedlings growing on the pad in front of the portal (Photo 6), but I did not see any on the outslope (Photo 7). It is too early to determine what species are present. I understand this seeding was done by the Alta ski resort.

Photo 7. The pad outslope.
